# What Routine EHC Fluid Analysis Fails to Detect: Improved Phosphate Ester Maintenance Through Non-Routine Testing

Hobbs, Matthew G.  
EPT, 4772 50<sup>th</sup> Avenue S.E. Calgary, AB, Canada  
mhobbs@cleanoil.com

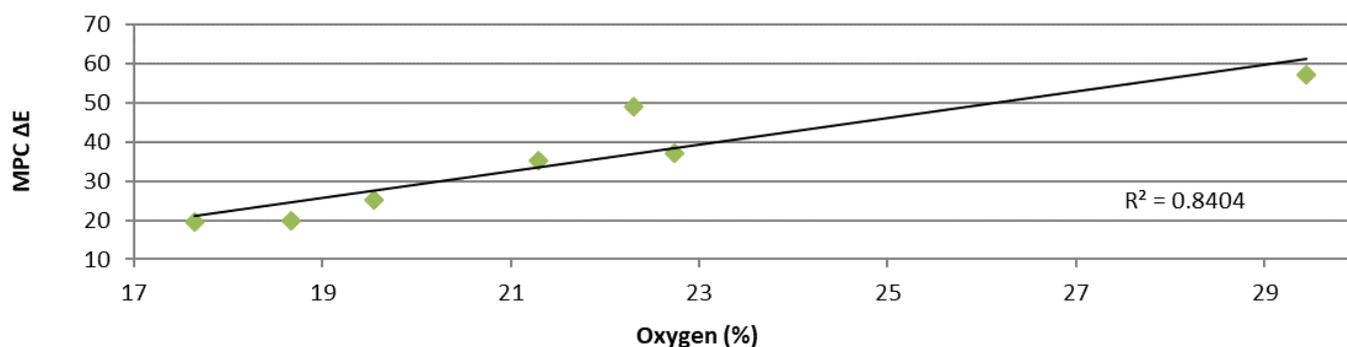
**Figure 1: Colorimetric Intensity of Amber-Brown Phosphate Ester Deposits as a Function of the Degree of Oxidation.**

By plotting the MPC ΔE of the 7 amber-brown phosphate ester patches examined in Table 3 as a function of their oxygen content, we established that the intensity of the amber-brown patch residues correlated with their degree of breakdown (Figure 1). This finding suggests that MPC can be used as a predictor of phosphate ester varnish potential for amber-brown phosphate ester patches.

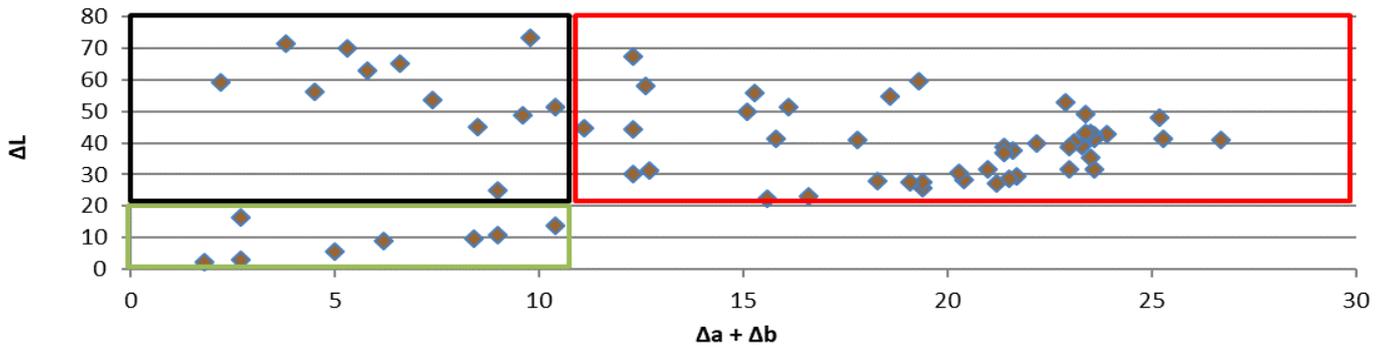
**Figure 2: Spectrophotometric Contributions to Phosphate Ester Membrane Patch Colorimetry.**

While the ubiquitously reported MPC  $\Delta E$  offers no means of distinguishing between black carbon and amber-brown phosphate ester varnish, the spectrophotometers used to measure  $\Delta E$  can also determine  $\Delta L$ ,  $\Delta a$  and  $\Delta b$ . Indeed, these parameters are the colorimetric contributors used to calculate  $\Delta E$  (Equation 1), where  $L$ ,  $a$  and  $b$  are the white/black, red/green and yellow/violet contributors to a patch’s color, respectively. Amber-brown phosphate ester varnish, therefore, features a significant contribution from the  $a$  and  $b$  parameters. Patches that are black due to carbon, on the other hand, have a significant  $\Delta L$  with little  $a$  or  $b$  contribution. This suggests that  $L$ ,  $a$  and  $b$  could be used to objectively distinguish between carbon and varnish in phosphate esters.

An analysis of the spectrophotometric properties of 65 different in-service phosphate ester filter patches revealed no correlation between  $\Delta L$  or  $\Delta(a + b)$ , however, the obtained data distribution was non-random (Figure 2). Examination of the plot revealed that 3 of its 4 quadrants bore data points while the 4th quadrant bore none; this

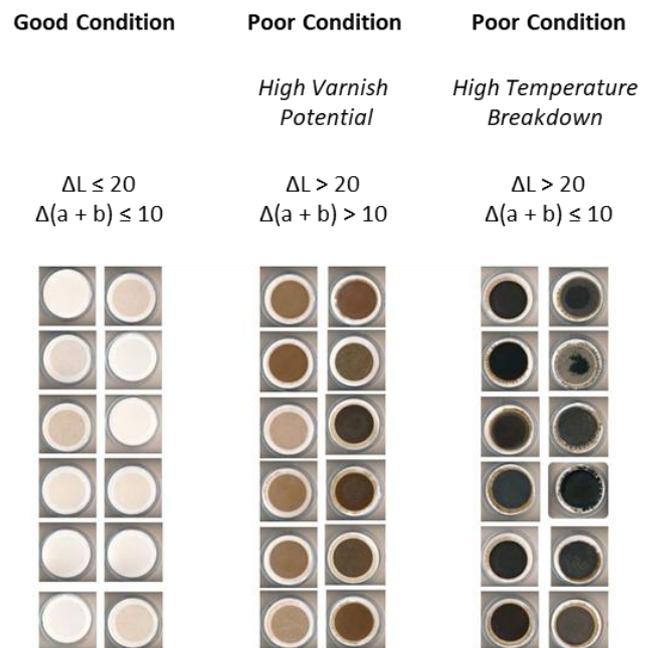
**Figure 3: Application of Limits to Phosphate Ester MPC.**

1. When  $\Delta L$  and  $\Delta(a + b)$  are both low (green quadrant), there is little amber-brown or black contribution to patch color. These patches is light because there are few or no fine insoluble contaminants and the EHC fluid is in good condition.
2. When  $\Delta L$  is high but  $\Delta(a + b)$  is low (black quadrant), the patch is dark with little or no amber-brown contribution. The EHC fluid is in poor condition owing to the presence of black carbonaceous insolubles; it is unlikely to produce varnish.
3. When  $\Delta L$  and  $\Delta(a + b)$  are high (red quadrant), the patch is dark as a result of intense amber-brown deposits. The EHC fluid in this scenario is in poor condition, featuring a high level of phosphate ester varnish.

Based on the obtained results, it is apparent that MPC spectrophotometric contributions ( $\Delta L$  and  $\Delta(a + b)$ ) can be used to objectively qualify phosphate ester varnish potential. Indeed, phosphate ester EHC fluids which produce elevated MPC  $\Delta(a + b)$  readings possessed elevated varnish potentials. This overcomes a significant limitation with the currently-established MPC test protocol since  $\Delta E$  measurements fail to distinguish between the products of phosphate ester thermolysis and phosphate ester varnish. When limits are applied to phosphate ester MPC analysis, its potential utility as a condition monitoring tool for steam turbine operators becomes immediately apparent (Figure 3).

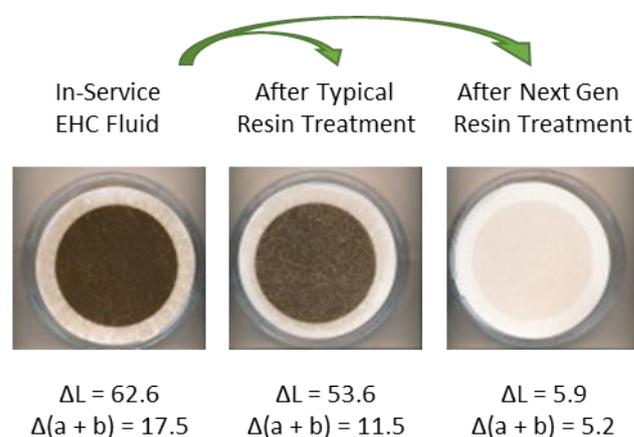
**Figure 4: Improved Phosphate Ester Varnish-Removal Abilities of Next Generation Ion Exchange Resins.**

When one understands the composition and means by which phosphate ester varnish forms, however, novel next-generation ion exchange resins can be engineered to effectively remove the phosphate ester varnish that standard resins and electrostatic devices leave behind. Indeed, the recent development of resins that remove acidic *and* varnishing phosphate ester breakdown products represents the most significant improvement to EHC fluid maintenance practices in the past decade (Figure 4).

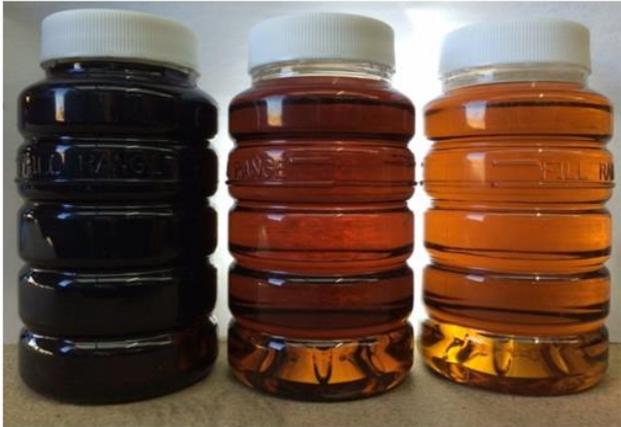
Figure 5: Improvement of EHC Fluid Appearance Following Electrostatic Filtration.

In an effort to address the extreme level of contaminants detected by MPC, management at Site “C” installed an electrostatic contaminant removal system. Following this installation, regular phosphate ester MPC analyses were conducted to monitor the unit’s effectiveness. Even before the first lab results were available, operators at Site “C” noted that the fluid’s color and appearance improved rapidly (Figure 5). These obvious improvements were mirrored by similarly dramatic improvements in the fluid’s patch weight and MPC values (Figure 6). Indeed, gravimetric patch weight determinations revealed that electrostatic filtration removed 98% of the fine insolubles present at Site “C” while its patch color also improved. It is interesting to note that, based on mass, the majority of the contaminants in this system were carbonaceous. These

were rapidly removed. Without these carbonaceous fines, the once-black MPC patches took on an amber-brown coloration. This suggested that the EHC system at Site “C” suffered from dieseling and varnish problems; the dominance of the former, however, masked the presence of the latter. While continued electrostatic filtration kept the fluid’s patch weight low, its improved MPC values fluctuated between  $\Delta L \approx 20 - 45$ . These fluctuations were the result of the complex equilibrium between the soluble and insoluble forms of phosphate ester varnish.

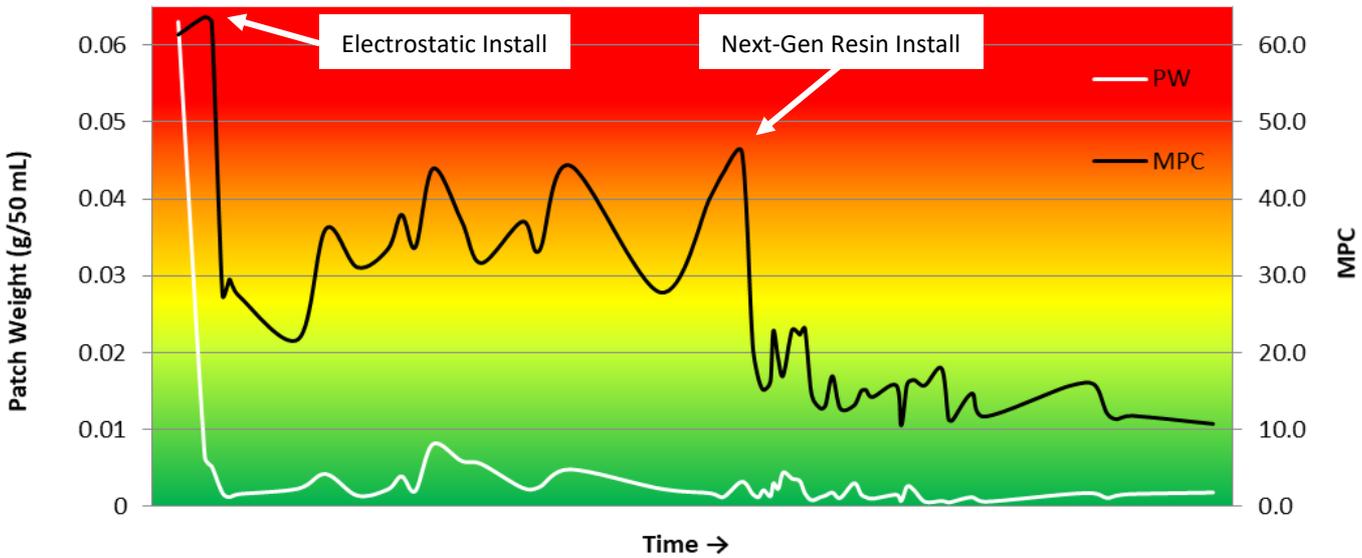
Figure 6: On-Site Removal of Carbon and Phosphate Ester Varnish via Electrostatic Filtration and Next Generation Ion Exchange Treatment as Measured by Patch Weight (PW) and Patch Color (MPC).

In an effort to address their continuing varnish problem, operators at Site "C" elected to replace their conventional ion exchange resin with a next-generation product specifically engineered to remove phosphate ester varnish. Following this resin change, the fluid's MPC values improved by a further 77%. Complex equilibrium effects continued to lead to some MPC fluctuation, however, the next generation resin capably maintained MPC values within the acceptable range ( $\Delta L \leq 20$ ) (Figure 6).

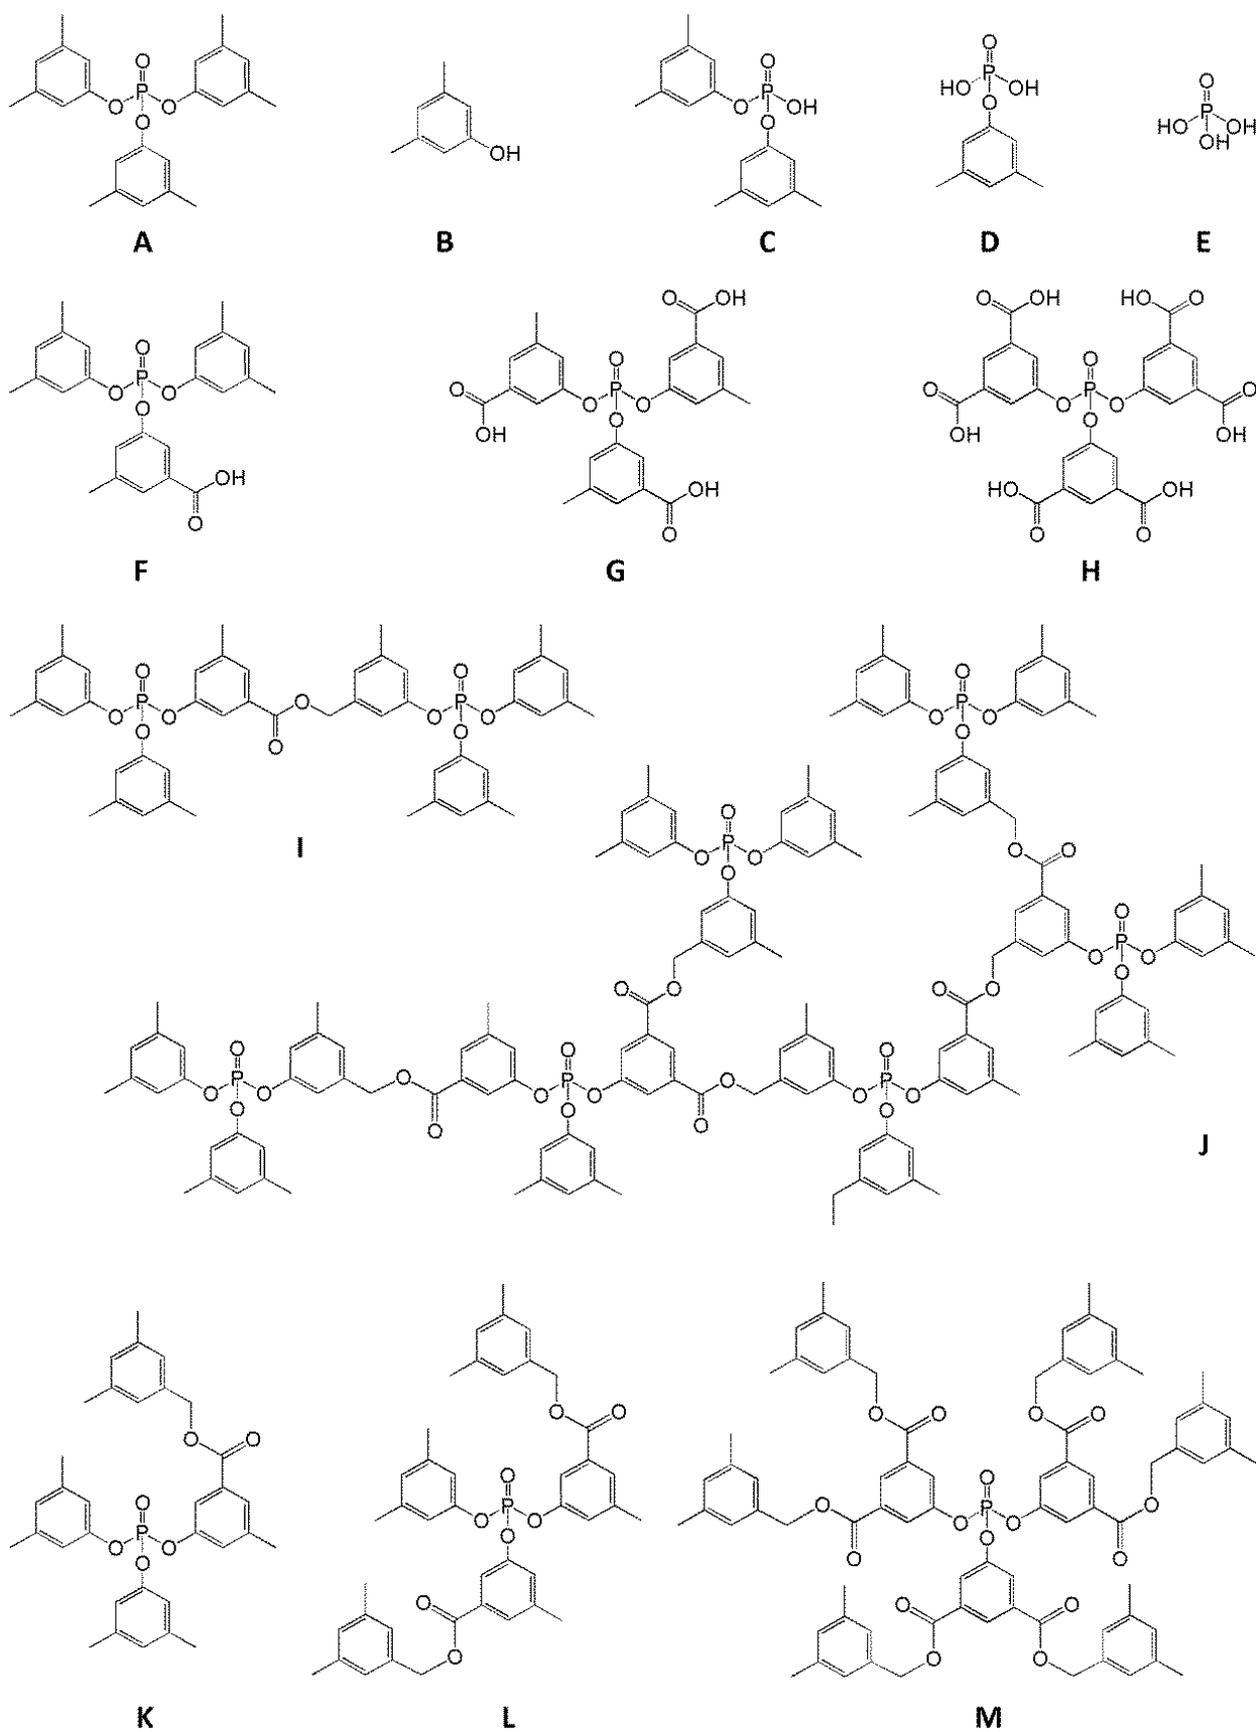
Figure 7: Proposed Phosphate Ester Breakdown Product Structures.
