Case Studies

Turbine Lubricant Varnish Removal

Studies using SVR®

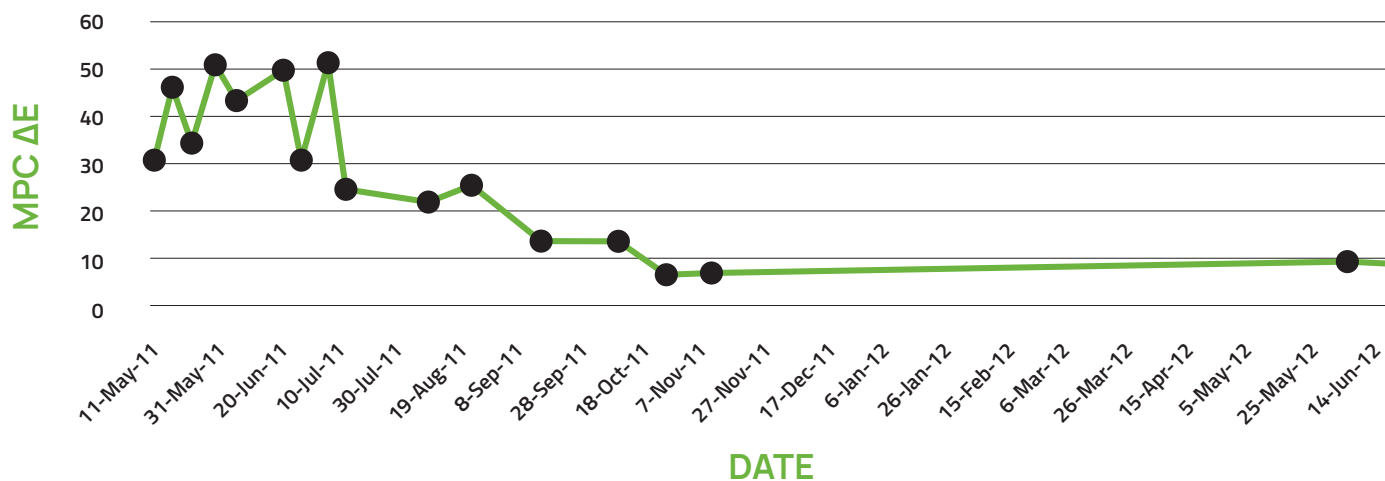
MPC ΔE REDUCTION USING SVR / MOBIL DTE 732

This site was experiencing a build-up of varnish on mechanical components. An SVR was installed and initial results described a three-month stabilization period as varnish deposits were adsorbed back into the lubricant. A significant decreasing trend began after four months of operation, which means that varnished mechanical components had been completely cleaned. SVR treatment reduced the fluid varnish potential value to below 10 over the subsequent three months. Varnish potential values are now stable and at historically low values.

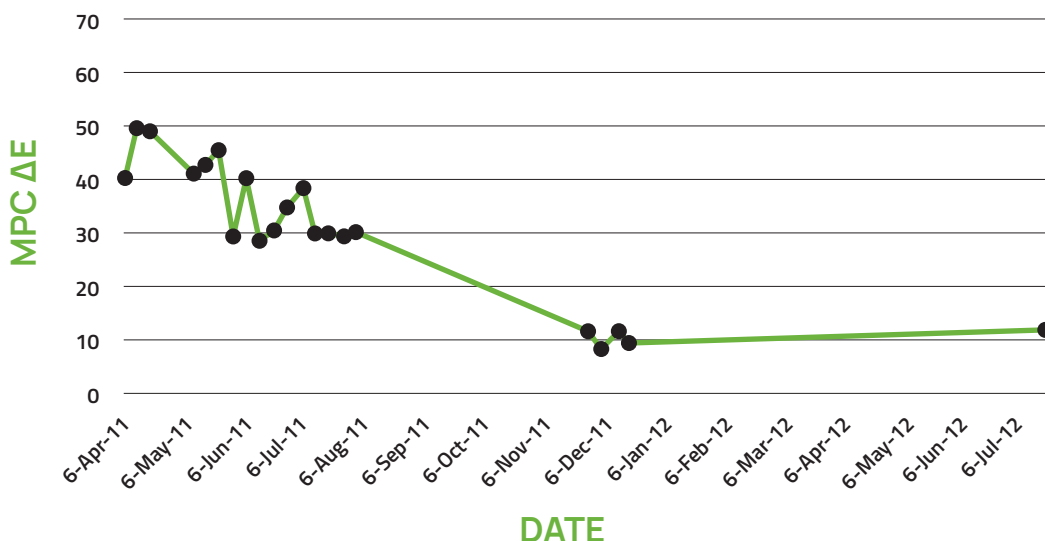
MPC ΔE REDUCTION USING SVR / MOBIL DTE 732

This site had a history of varnish problems; the customer consistently experienced build-up of varnish on mechanical components. Once SVR was installed, varnish potential numbers fluctuated over a two month period while varnish deposits were adsorbed into the lubricant. Notable reductions were achieved by month three. Consistent reductions continued over the next six months. Permanent use of SVR has been able to reduce varnish potential values by another 60% and to be maintained at 15 or below. Varnish potential values are now stable and at historical low values.

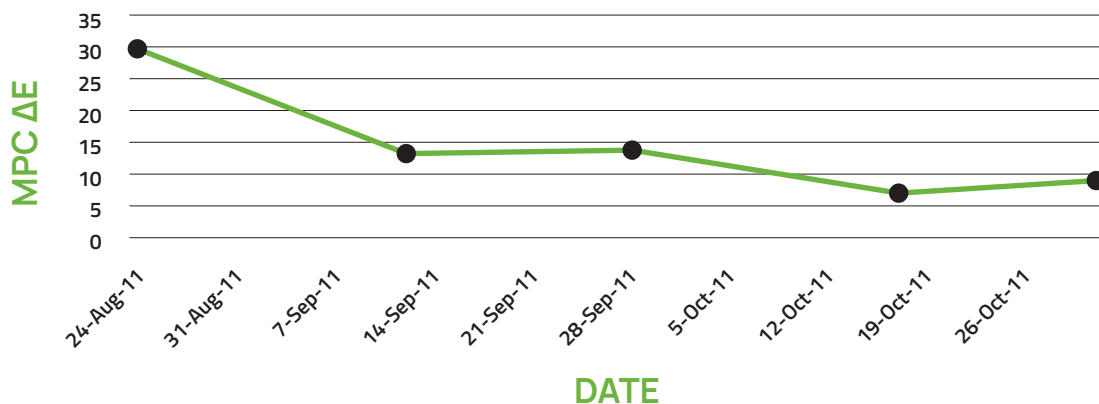
MPC ΔE REDUCTION USING SVR / SHELL TURBO CC 32

This site had a history of varnish problems with QSA® varnish potential values at 75 or higher. Previous efforts on the part of maintenance staff were unable to control varnish potential values, which was a significant concern for the turbine owner. Upon installation of SVR, varnish potential values were quickly reduced. MPC varnish potential values are now at 10 or lower.

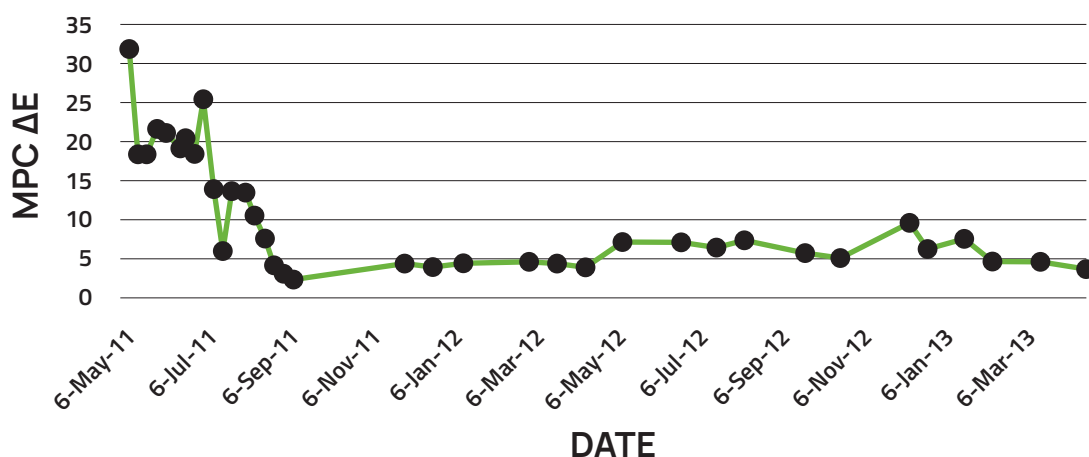
MPC ΔE REDUCTION USING SVR / SHELL TURBO TX 32

This turbine is used as the primary generator at an oil and gas production facility. High varnish potential values were of concern due to the critical nature of the turbine and the potential loss in production associated with any turbine outage. SVR was installed and quickly reduced varnish potential values by >50%. Further decreases were observed with continued SVR use. Varnish potential values are now less than 5.0 and stable.

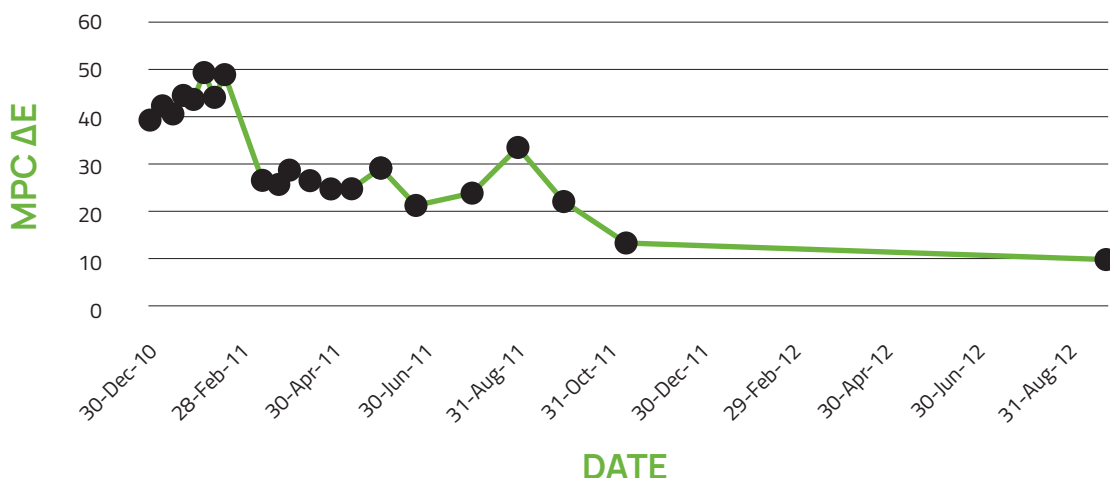
MPC ΔE REDUCTION USING SVR / MOBIL DTE 832 / SHELL TURBO CC 32 MIX

This unit had a history of varnish problems with multiple unit trips and fail-to-start conditions. SVR systems were installed on all turbines and quickly reduced varnish potential by over 50% with no further turbine failures occurring. Continued long term use of SVR has been able to reduce varnish potential values by another 40% with values now at <15. Varnish potential values are now stable and at historical low values.

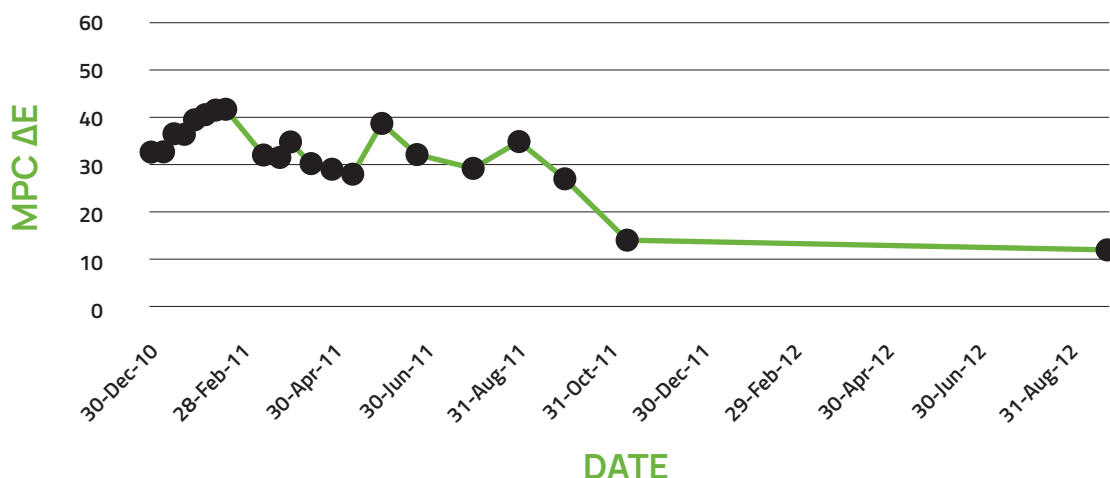
MPC ΔE REDUCTION USING SVR / MOBIL DTE 832 / SHELL TURBO CC 32 MIX

Unit had a history with multiple trips and fail-to-start conditions. SVR system was installed on this unit and within six months had produced downward trending MPC results. No turbine failures occurred after the SVR system was installed. The length of time prior to decreasing MPC is based on the amount of varnish on system components. The varnish potential is now below 15 and continues to decrease.

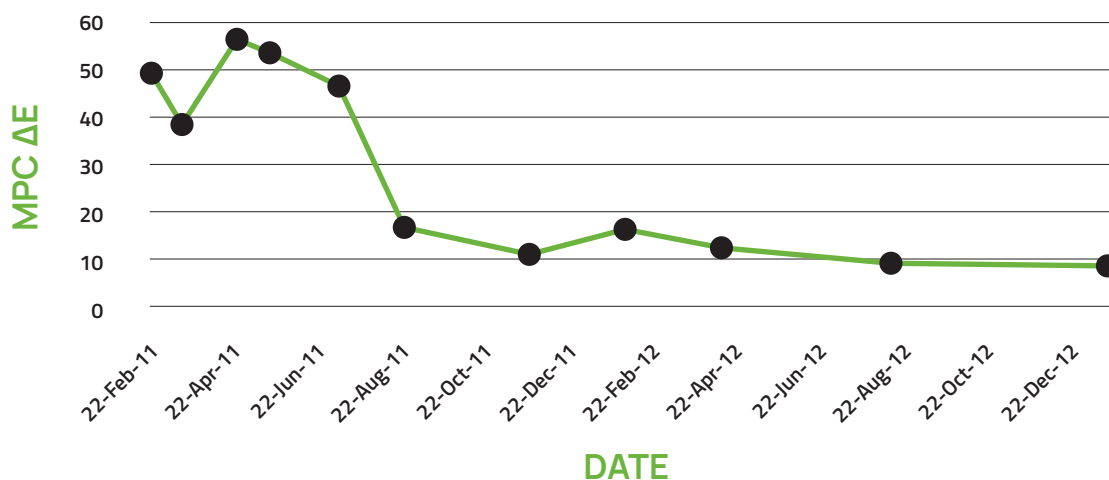
MPC ΔE REDUCTION USING SVR / TERESSO GTC 32

An electrostatic oil cleaner was operational on this system full-time since turbine commissioning in 2009. Within 18 months of initial operation, varnish potential values had increased above 40 to critical levels. SVR was installed February 2011 and reduced varnish potential, which then increased as system deposits were adsorbed back into the lubricant. Subsequent element changes performed annually have achieved stable and historically low varnish potential values.

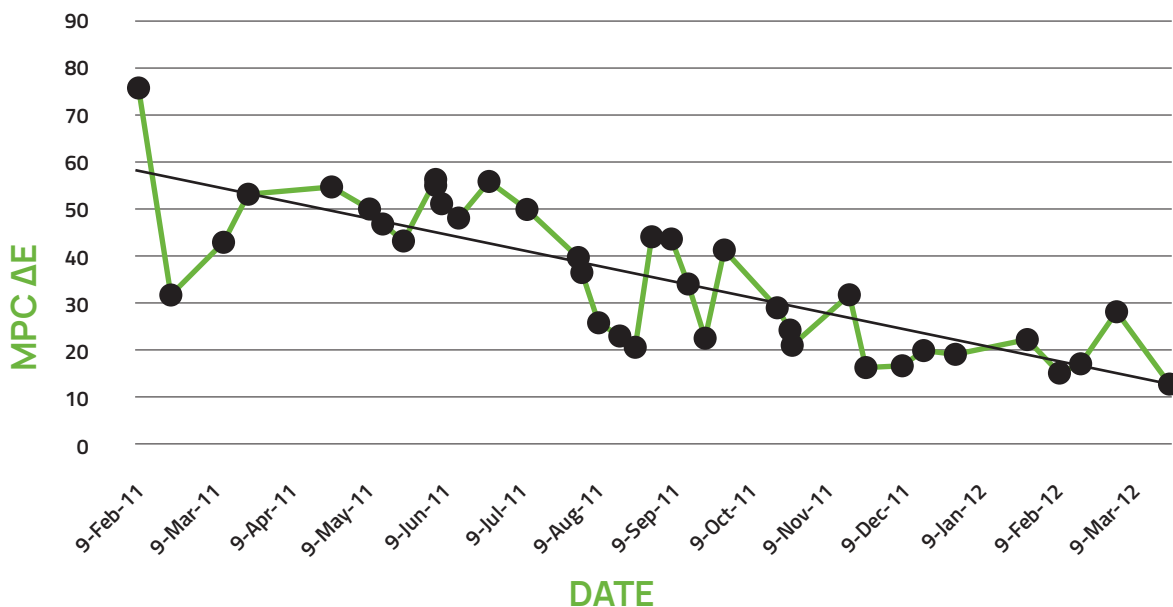
MPC ΔE TRENDING USING SVR / SHELL TURBO CC 32

When initially contacted, this site had extreme varnish potential values. SVR was installed and immediately reduced varnish potential values by >60%. Existing system deposits were then adsorbed back into the lubricant which increased varnish potential values. Based on the level of increase, the results suggest that existing system varnish deposits were above average. Secondary decreases followed by increases also suggest above average levels of varnish deposits were present. The system stabilized after eight months of SVR treatment. No additional operational problems have been experienced and varnish potential values remain at historically low levels.

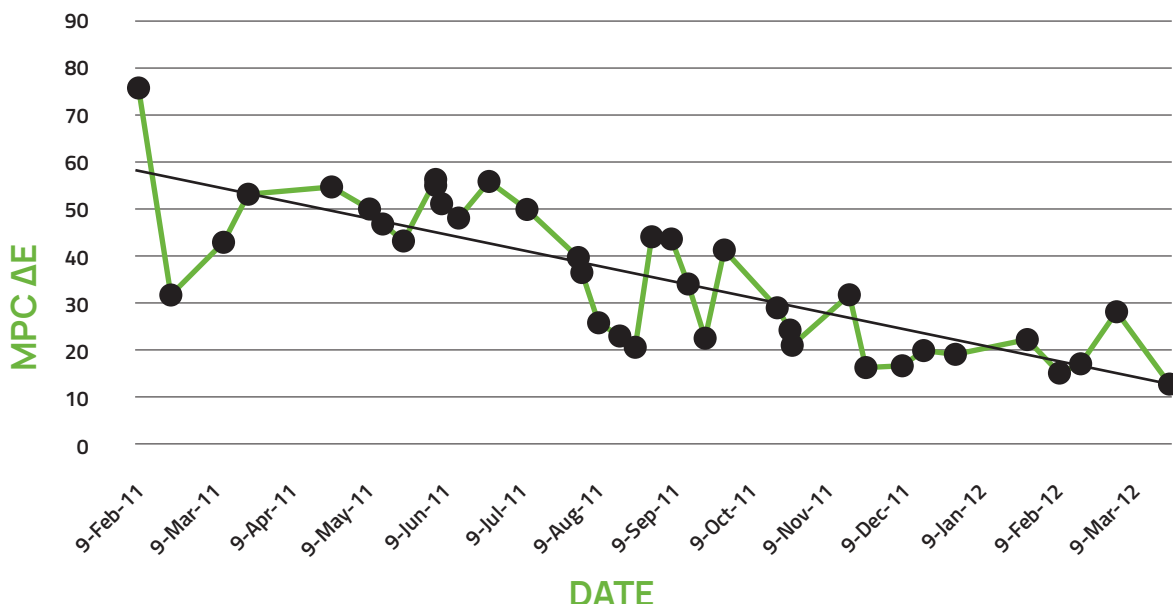
MPC ΔE TRENDING USING SVR / MOBIL DTE 724

At this facility, three GE 7FA Gas turbines provide the primary power and steam for the chemical plant. Plant reliability was negatively impacted from elevated varnish potential numbers in the gas turbine. To reduce the risk of outage maintenance staff tried a number of varnish removal systems without success. SVR was installed and had an immediate impact, reducing varnish potential numbers and within three months, values had been reduced by 80% to a varnish potential value of <5. Based on these successful results, SVR has been installed on all three gas turbines at this site.
