ICB® AW Case Study

Application: Hydraulic Press

Site: Graphite Electrode Manufacturing Plant

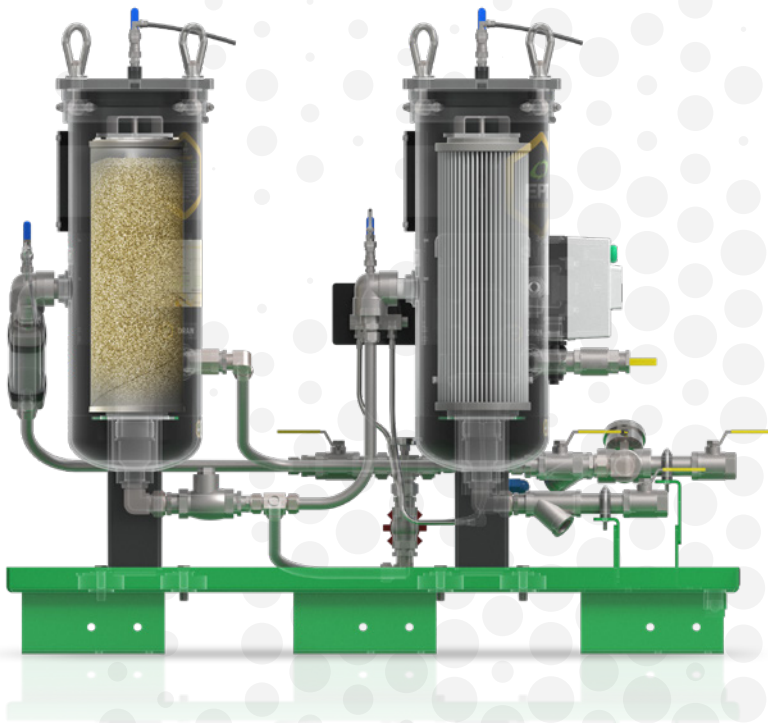
HYDRAULIC PRESS

Varnish-accumulation in the Plant's hydraulic press led to reliability issues. At its peak, this problem had a significant impact on the plant's production. Oil analysis revealed that the press' AW hydraulic oil had a high MPC varnish potential as the result of normal breakdown during its service.

An SVR® Lubricant Conditioning skid employing ICB® AW filters was installed on the Press.

The installed SVR Skid/ICB AW filters effectively removed varnish and its soluble precursors from the site's hydraulic press, improving its MPC varnish potential by 87%. Most importantly, ICB AW's selective engineering allowed the filters to remove varnish without any adverse impact on the oil's AW additive levels. Once the varnish was removed from the system, continued oil conditioning prevented it from accumulating again. Varnish-related failures are a thing of the past at this site as the result of SVR/ICB AW.
