ICB® FRF CASE STUDY

Site: 602 MW Gas-Fired Combined Cycle
Plant with a Siemens KN Steam Turbine

Site: 525 MW Gas-Fired Combined
Cycle Plant with a GE D11 Steam Turbine

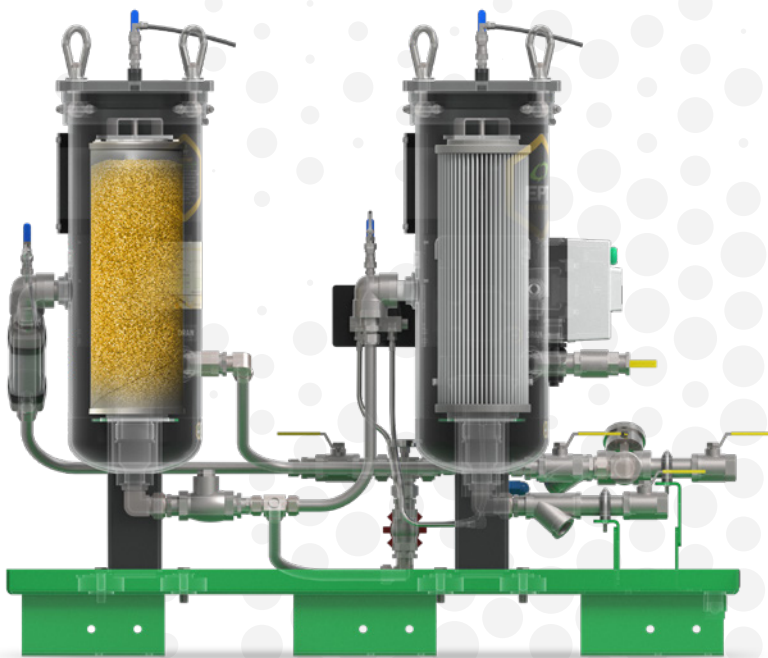
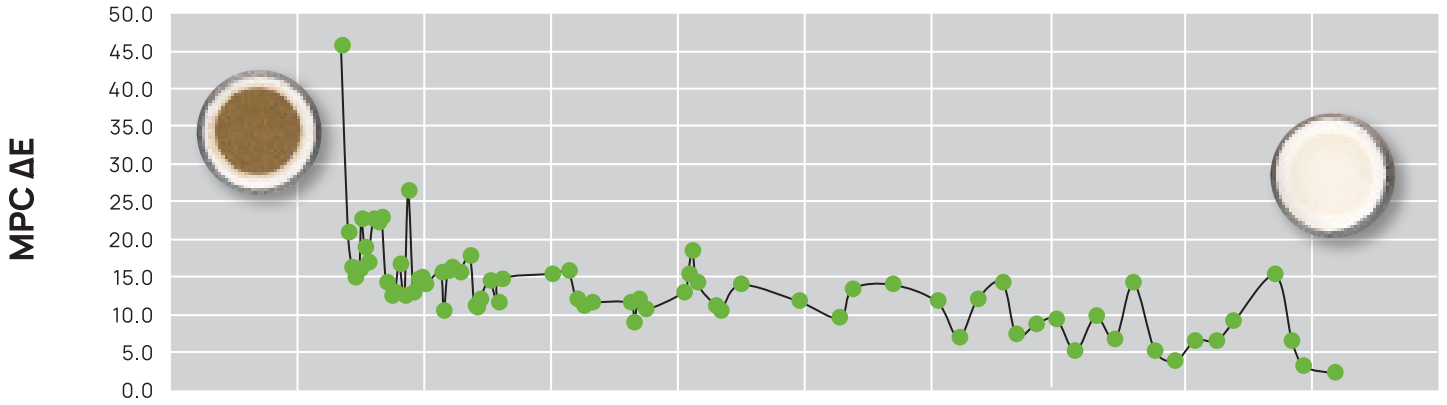
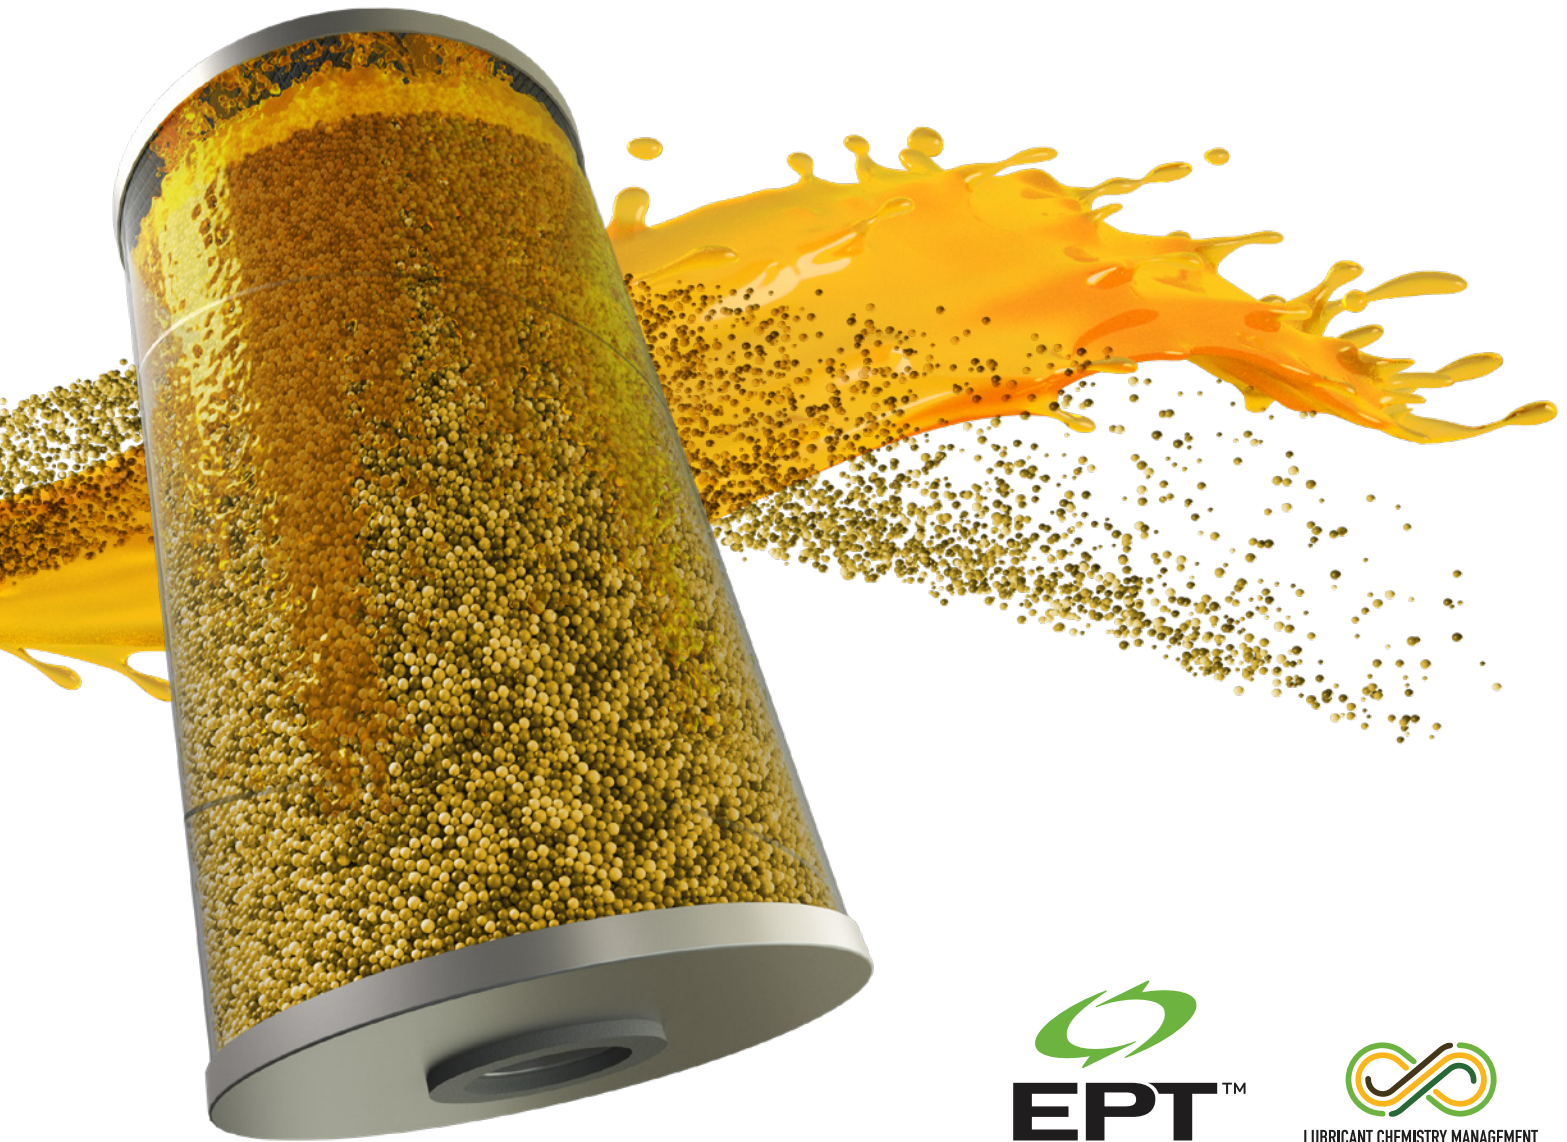
The installed ICB FRF filters effectively removed varnish and its soluble precursors from the site's FRF, improving its MPC varnish potential by 95% and maintaining its acid number and resistivity within the application's required ranges. Since the filters were installed, valve failures have been eliminated and the costly FRF has not needed to be replaced for 5 years (and counting).

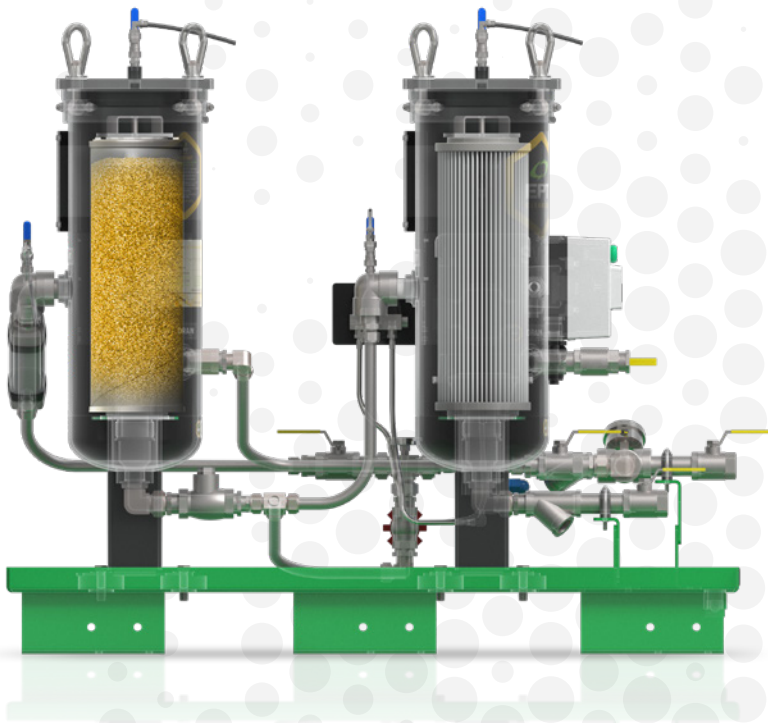
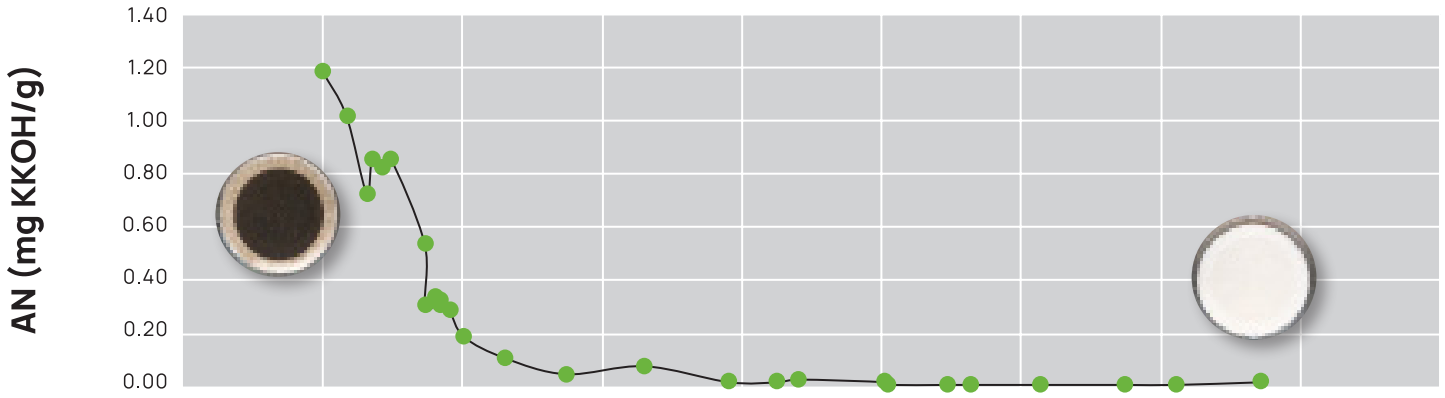
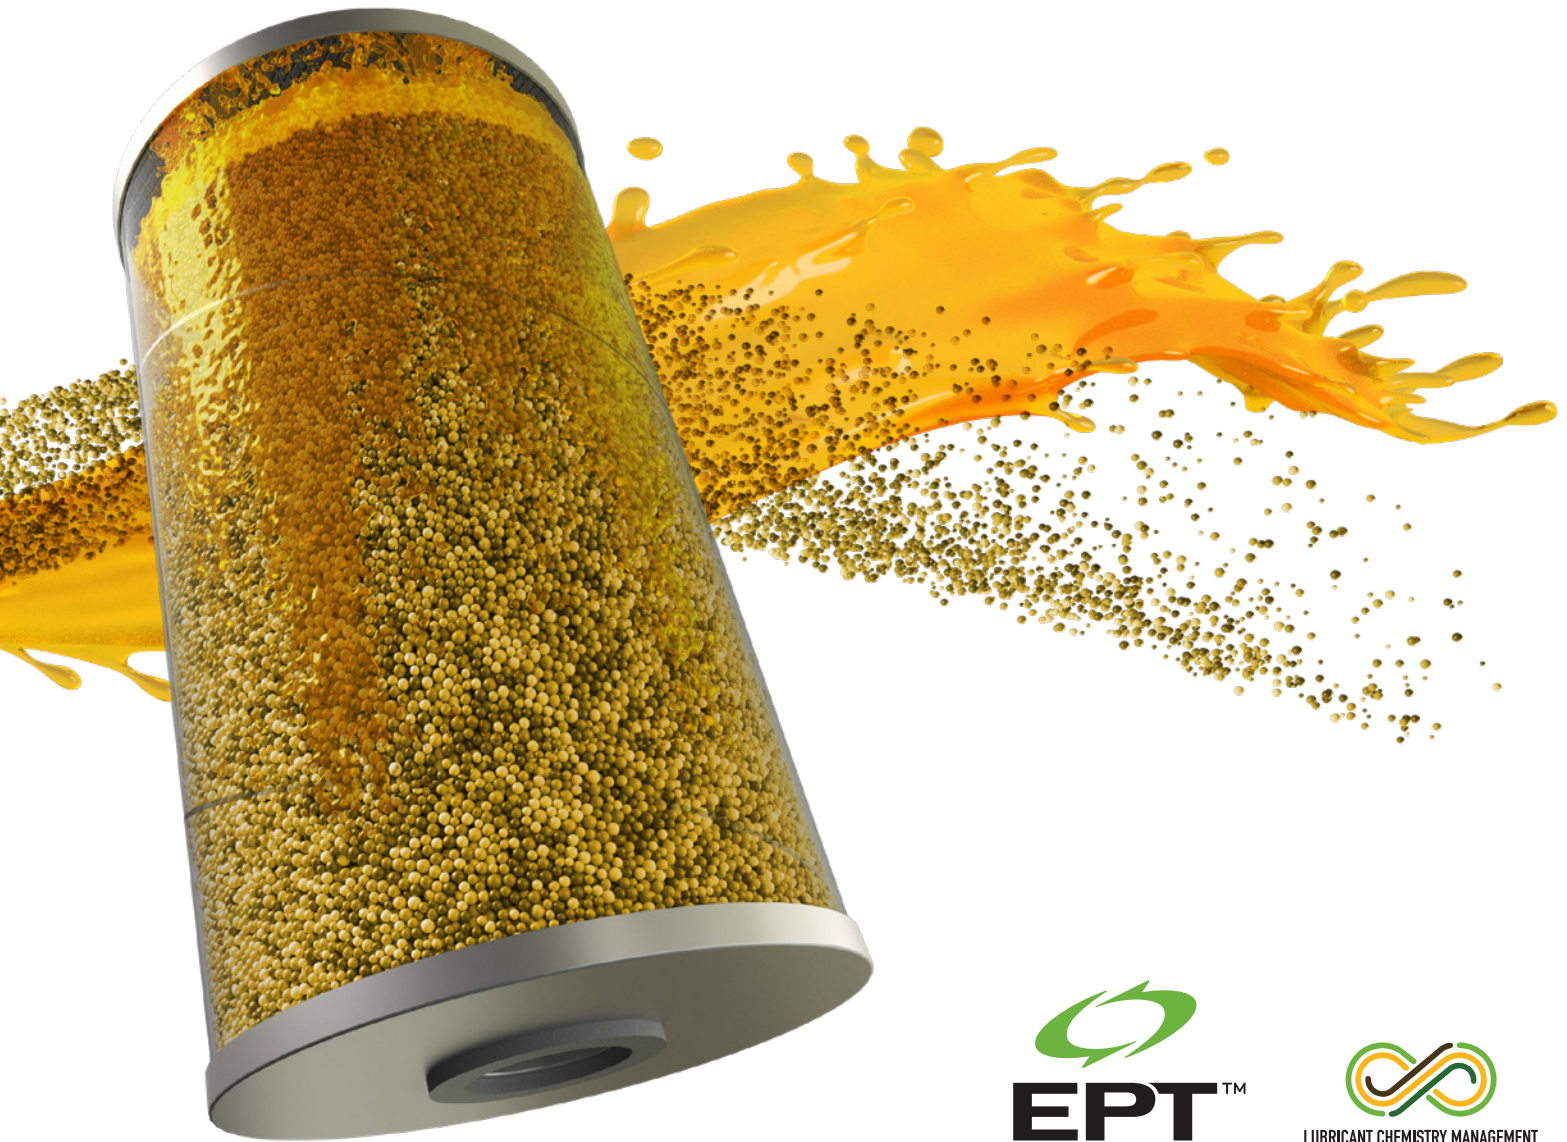
By regularly changing their ICB FRF filters at monthly intervals, the Power Plant operator was able to remove acids that were present, restoring their FRF's acid number to acceptable levels. As an additional benefit of ICB conditioning, the FRF's MPC varnish potential and resistivity were also brought back to within specification. Once the FRF was restored, continued oil conditioning prevented varnish and acids from accumulating again. Oil condition-related failures are a thing of the past at this site as the result of SVR/ICB FRF and the Plant enjoyed significant savings as the result of no longer needing to replace their costly, synthetic FRF.
