ICB® RO Case Study

Application: Pipeline Compressor Station

Application: Compressor Driver (Gas Plant)

Application: Power Generation

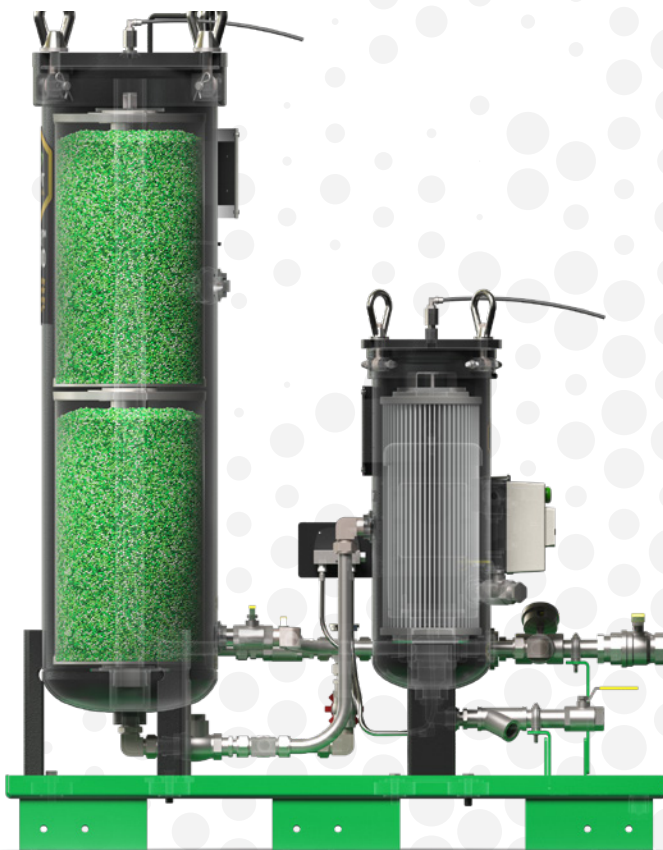
POWER TURBINE

The installed SVR Skid complete with ICB® RO filters effectively removed varnish and its soluble precursors from the site's power turbine, improving its MPC varnish potential by 94%. Once the varnish was removed, continued oil conditioning prevented varnish from accumulating again.

Since the SVR complete with ICB RO filters was installed, the Power Turbine has operated reliably within an acceptable temperature range.

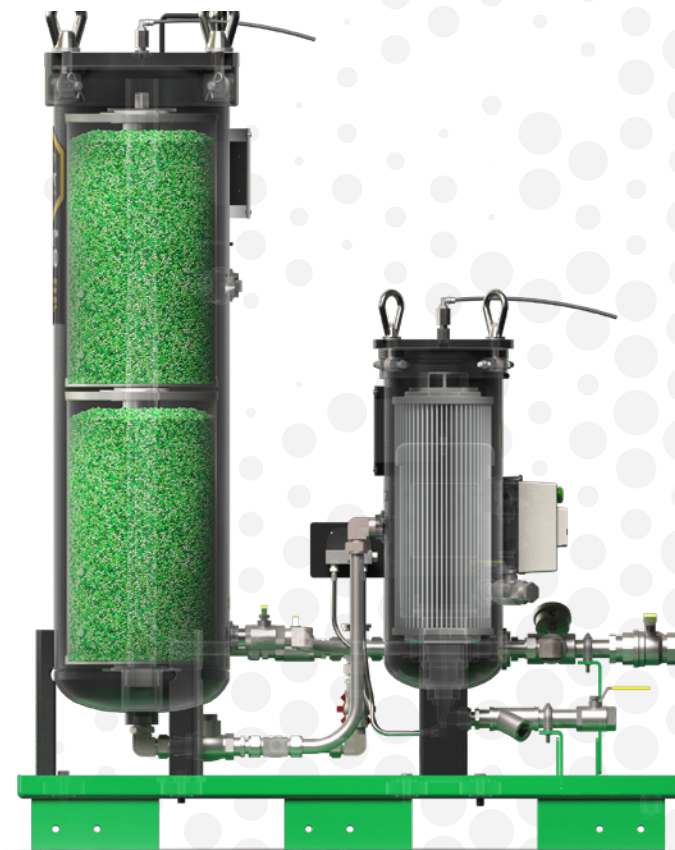
COMPRESSOR DRIVER (GAS PLANT)

For more than a decade of baseload operation, the Plant's SVR/ICB RO filters have effectively removed varnish and its soluble precursors. These oil breakdown products form as a normal function of service. Typically, they accumulate until they cause high MPC varnish potentials and reliability issues. By conditioning their oil with SVR/ICB RO Filters, this Gas Plant has been able to maintain a near-zero MPC varnish potential and their Compressor Driver has not experienced a single oil-related failure or issue during its lifetime.

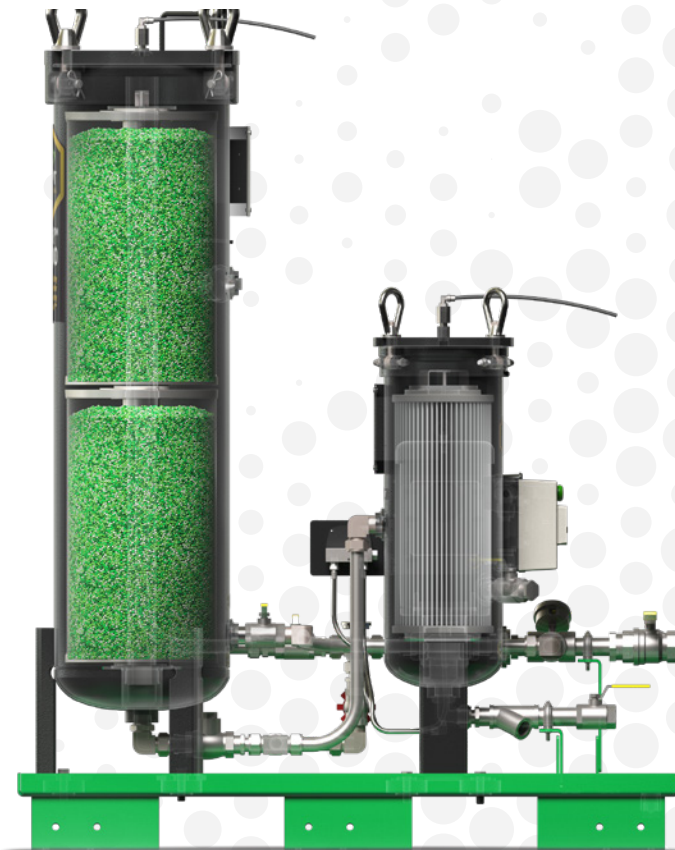
DEMULSIBILITY

The installed SVR Skid/ICB RO filters effectively removed varnish and other soluble contaminants from the steam turbine oil. These breakdown products increase a fluid's tendency to form harmful emulsions. With them gone, the amount of emulsion that the oil produced fell by 95%, allowing the unit's coalescer to do its job. Free from water, the Plant's steam turbine has operated reliably ever since.

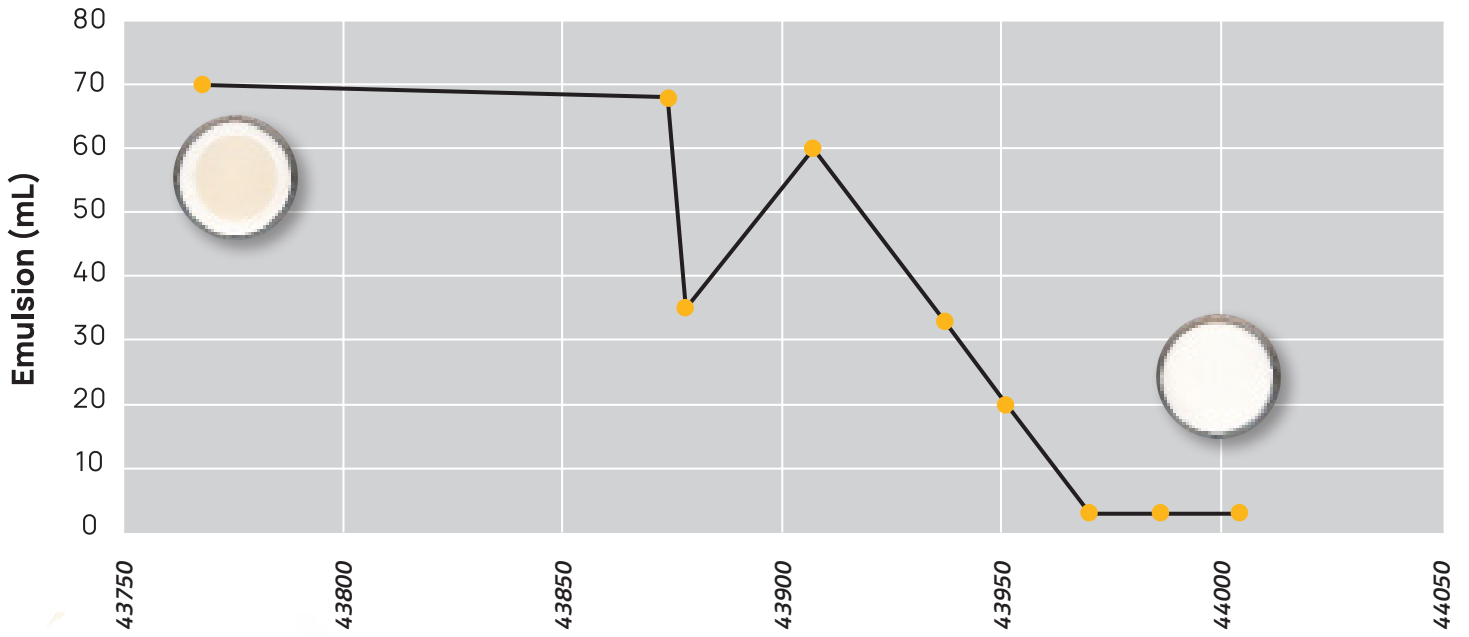
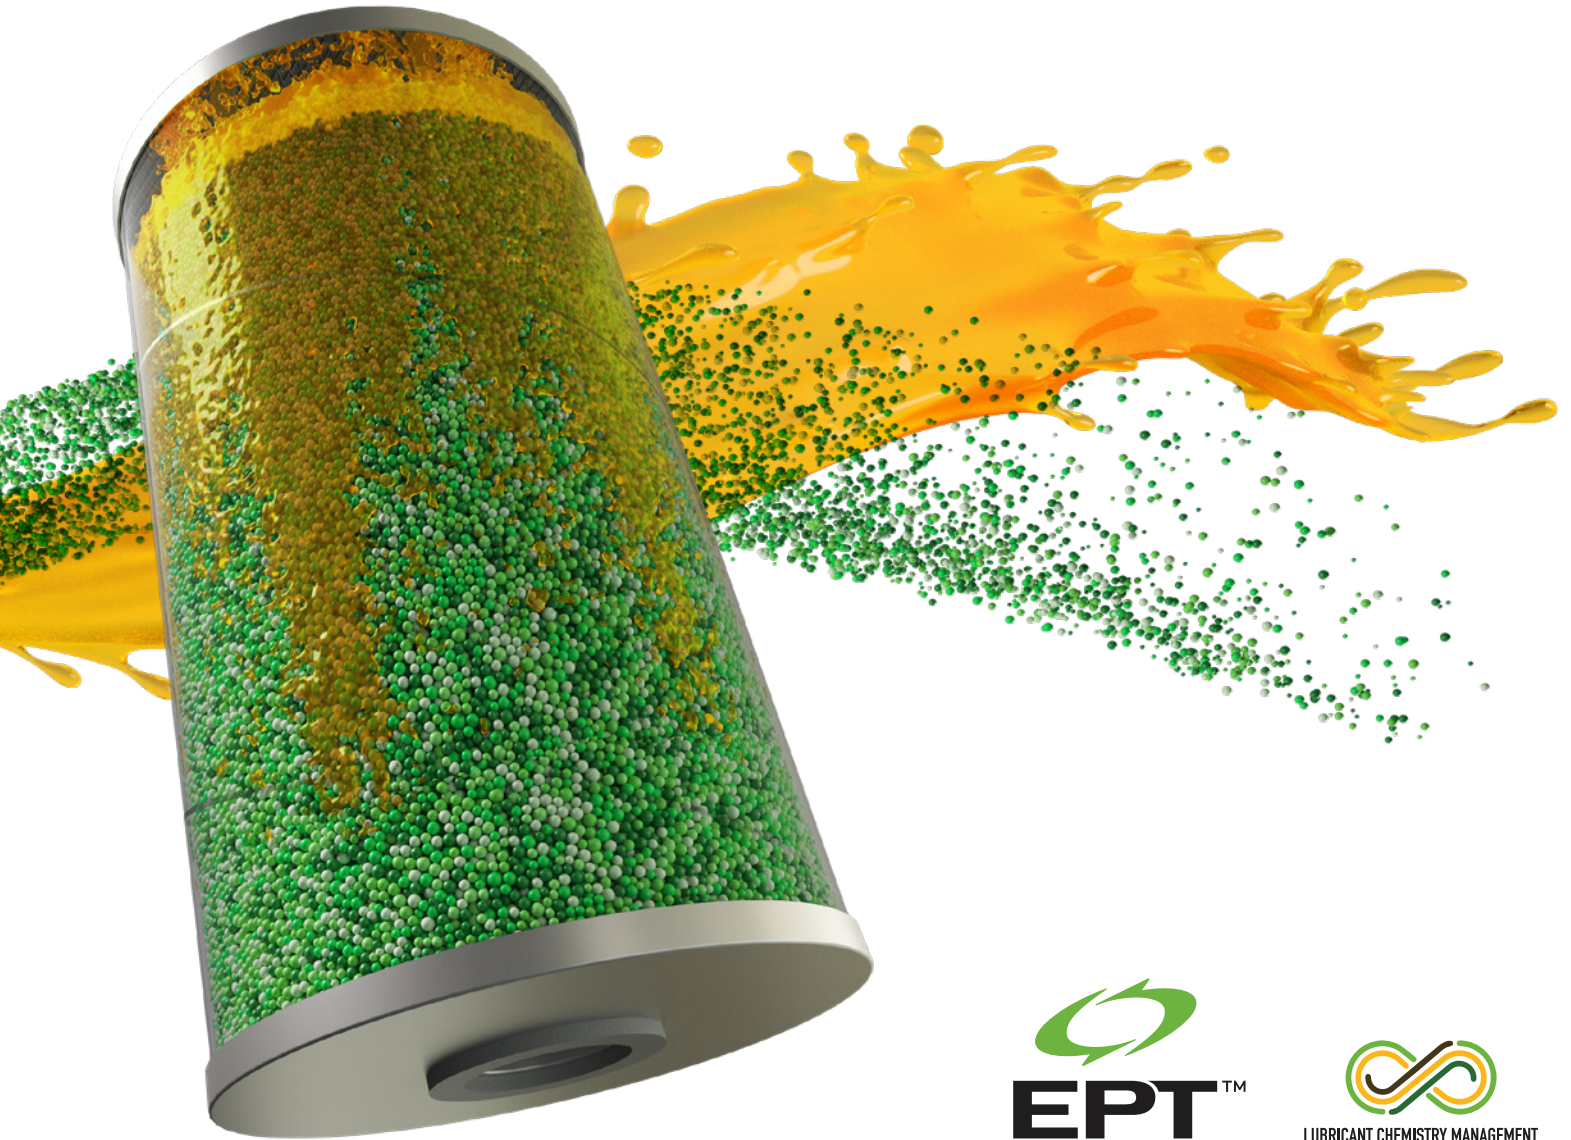
A coalescer was struggling to keep up with the amount of water making its way into one of the Plant's steam turbine lube oil systems. Oil analysis revealed that the lubricant's water separation abilities (demulsibility) had degraded significantly over time. As a result, the contaminant moisture in this system was present in an emulsified form which cannot be readily separated from the oil, significantly increasing the turbine's risk of failure.

An SVR® Lubricant Conditioning skid employing ICB® RO filters was installed on the Steam Turbine whose oil separated poorly from water.
